# TREMCO Roof Audit Report

*Prepared For* **Bayless School District**

Re: Roof Analysis Report  
Intermediate School

Bayless School District, Intermediate School

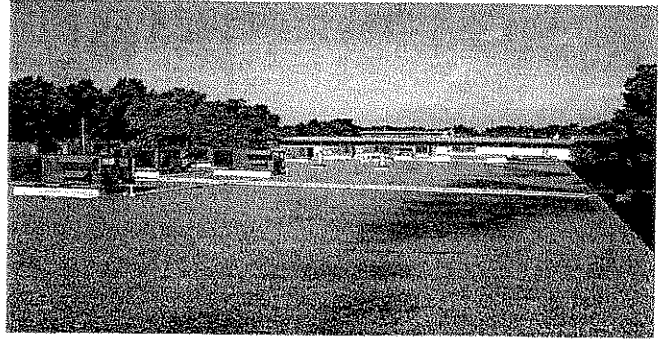
Overview photograph of the roof surface

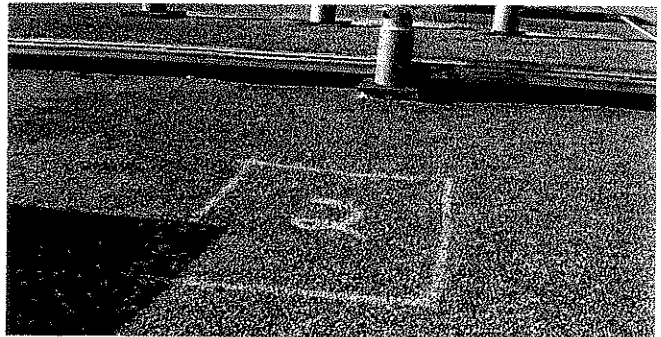
Infra-red analysis revealed isolated areas of wet insulation having a net area of approximately 70 sq. ft.

Areas of wet insulation were identified using infra-red technology

The areas of wet insulation must be removed. Water degrades the roof assembly from the structural deck to the membrane surface. It forms corrosive substances with organic elements in the roofing system that eat away at roof and structural components. Once inside a roof assembly, water can cause long-term deterioration and early roof failure.

Removal and replacement of the wet areas are recommended before wet areas spread and additional damage is done to the roof system.

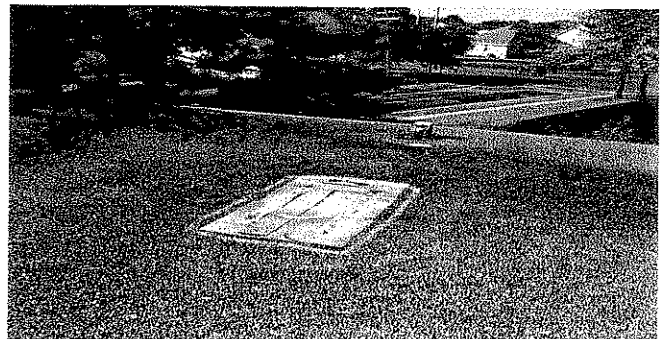
Areas of wet insulation were verified with moisture probes and marked on the roof surface

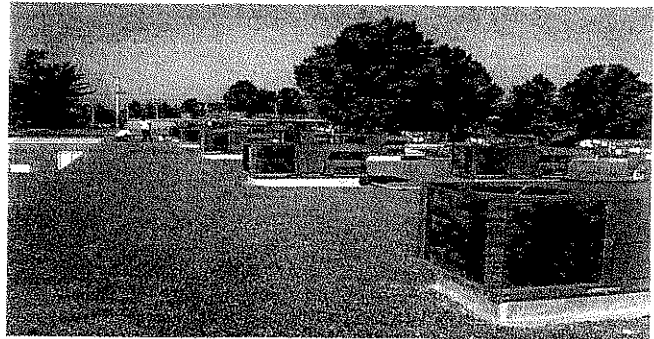
Overview photograph of the roof surface

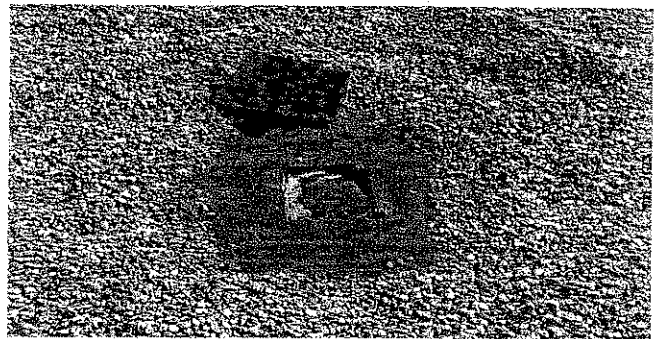
The infra-red analysis revealed that approximately 70% of the roof contains wet insulation. Insulation is often placed between the roof membrane and the structural deck as part of the roof system construction. If moisture infiltrates the system it can cause the insulation to become wet. Wet insulation can: increase the weight load on the deck, cause rusting or deterioration of the system components, cause delamination of the roof system., and create environmental issues.

Core samples were taken to verify the areas of wet insulation

Replacement is recommended before additional damage is done, larger expenditures are required, and environmental issues arise.

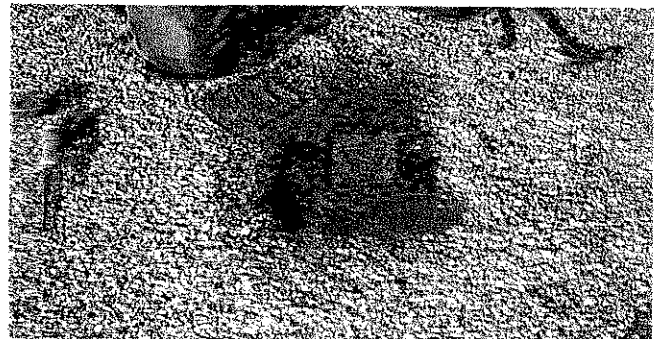
Core sample depicting saturated fiberboard roof insulation

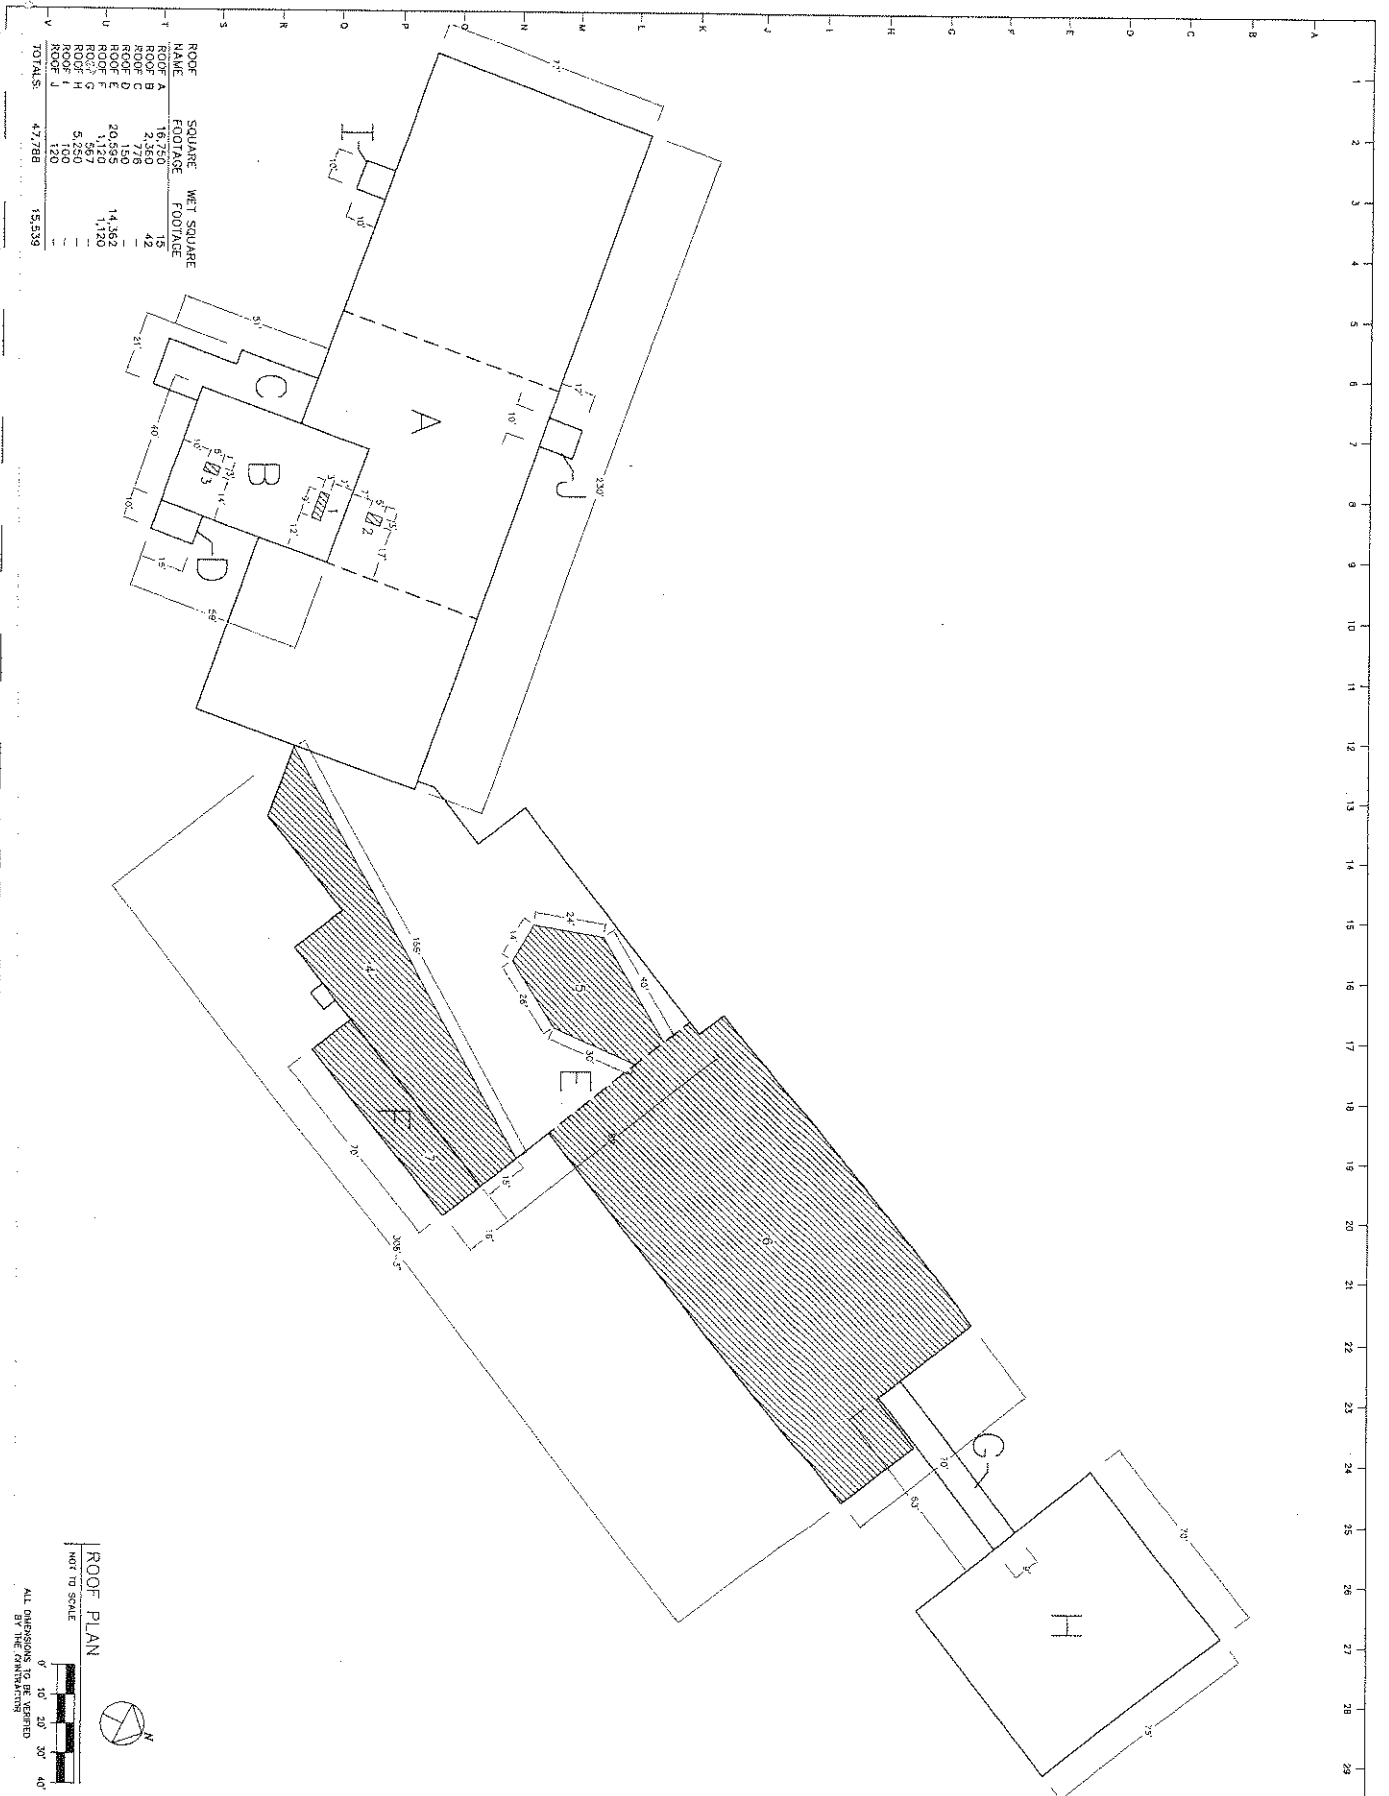
**ROOF PLAN**

ROOF NAME	SQUARE FOOTAGE	WET SQUARE FOOTAGE
ROOF A	16,750	15
ROOF B	2,350	42
ROOF C	150	—
ROOF D	20,595	14,362
ROOF E	1,120	1,120
ROOF F	5,250	—
ROOF G	100	—
ROOF H	120	—
ROOF I	120	—
ROOF J	120	—
TOTALS:	47,788	15,539
