# TREMCO Roof Audit Report

*Prepared For* **Bayless School District**

Re: Roof Analysis Report  
Intermediate School

Bayless School District, Intermediate School

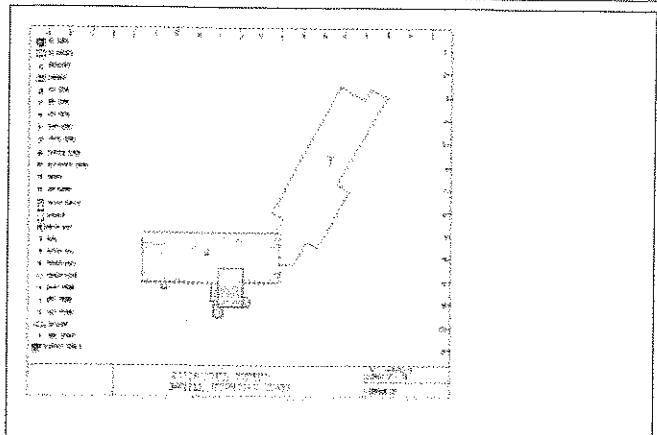
Roof Area A

This roof is in fair condition overall

Core samples and test cuts taken into the roof revealed the roofing plies are still laminated together with ample amounts of bitumen between the roofing plies, perimeter flashings are in good condition, surface aggregate is adhered, and the flood coat thickness appears to be sufficient.

Infra-red analysis revealed isolated areas of wet insulation having a net area of approximately 70 sq. ft.

The areas of wet insulation must be removed. Water degrades the roof assembly from the structural deck to the membrane surface. It forms corrosive substances with organic elements in the roofing system that eat away at roof and structural components. Once inside a roof assembly, water can cause long-term deterioration and early roof failure.

Removal and replacement of the wet areas are recommended before wet areas spread and additional damage is done to the roof system.

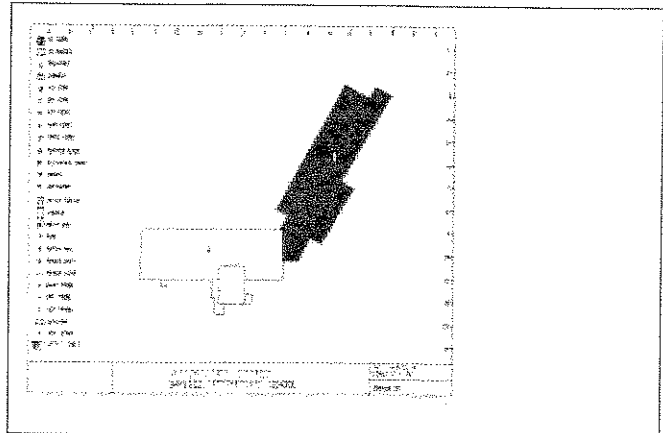
Roof Area B

Overall this roof is in poor condition

The infra-red analysis revealed that approximately 70% of the roof contains wet insulation. Insulation is often placed between the roof membrane and the structural deck as part of the roof system construction. If moisture infiltrates the system it can cause the insulation to become wet. Wet insulation can: increase the weight load on the deck, cause rusting or deterioration of the system components, cause delamination of the roof system., and create environmental issues.

Replacement is recommended before additional damage is done, larger expenditures are required, and environmental issues arise.
